**RE:** PRODUCT SAFETY NOTICE

### Important Product Safety Notice Involving 35708 Pulsers (“Notice”)

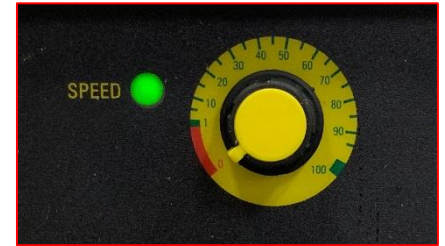
AML V2.0 Firmware

Milton Roy, owner of the LMI brand (“LMI”) has recently become aware of a firmware change (“AML v2.0”) in our 35708 Pulsers – the electronic component used to control the stroke speed (frequency) of our LMI P1, B1, C1, AA1 and Uni-Dose U1 pumps – that bounds the speed setting between 1% and 100%. This limits the user’s ability to set the speed to zero, even when the top knob is turned fully counter clockwise, indicated by the green light remaining on.

This Notice applies to the LMI P1, B1, C1, AA1 and Uni-Dose U1 pumps, purchased after **October 1<sup>st</sup>, 2018 with serial numbers starting with 1810, 1811, 1812, 1901, 1902, and 1903** where the green indicator light does not turn off when the speed knob is set to zero, and the speed remains at 1 SPM.

With this AML v2.0 firmware, turning the speed knob to zero while the pump remains plugged in will not stop it from stroking and could cause bodily injury if servicing the pump in this state. While we never advise using the top speed knob as a way of de-energizing the pump, we believe the visual indication on our speed knob may not accurately reflect stroke speed.

In this effort, we have designed the following dial overlay (part “57477”) to clarify the 1 to 100 SPM range and clearly instruct users that the pump will continue to stroke until the pump is unplugged and the green indicator light has turned off.

**For Distributors:** Please update all existing stock with the 57477 dial overlays. These will be provided as soon as they are available at no cost.

Promptly affix the 57477 dial overlay to any affected LMI P1, B1, C1, AA1 and Uni-Dose U1 pump containing the AML 35708 Pulser that may be in your inventory and provide us with confirmation that all affected pumps have been modified. We also request that you forward this notice electronically to all customers that have purchased an affected pump after October 1, 2018. Distributors will be compensated at the standard hourly rate for making the necessary changes.

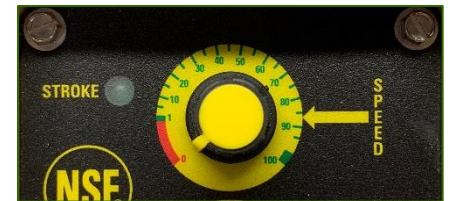
Previous v1.0 (and future v3.0) Firmware

The prior firmware bound this range between 0% and 100%, which allowed a zero state, where the green indicator light would turn off and the stroke speed would remain at zero SPM.
